# **TESTING OF PROTOTYPE CONDUIT**

**INTERIM REPORT  
TFLRF No. 401**

**U.S. Army TARDEC Fuels and Lubricants Research Facility  
Southwest Research Institute<sup>®</sup> (SwRI<sup>®</sup>)  
San Antonio, TX**

**for  
U.S. Army TARDEC  
Force Projection Technologies  
Warren, Michigan**

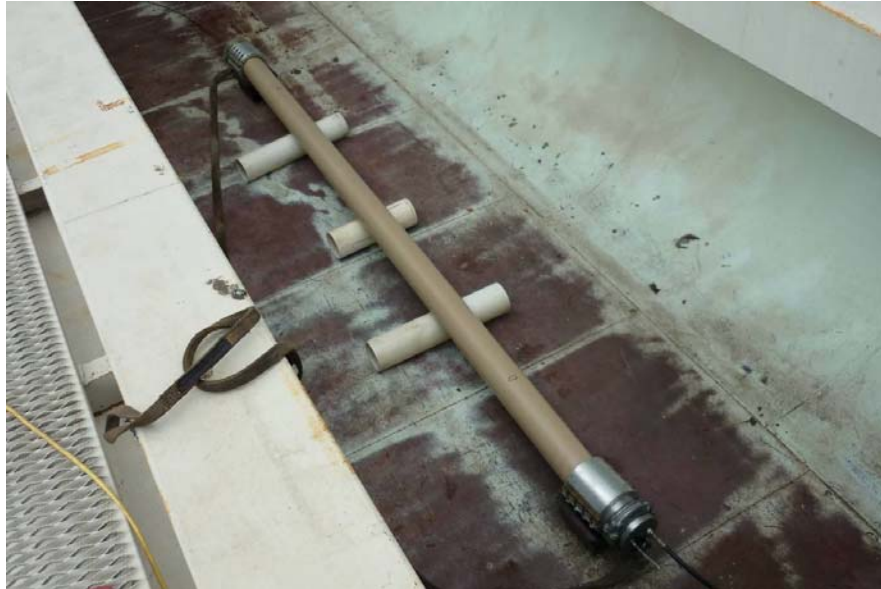
### **2.1 Hose Description**

**Figure 2.1 – Snap-Tite High Pressure Conduit**

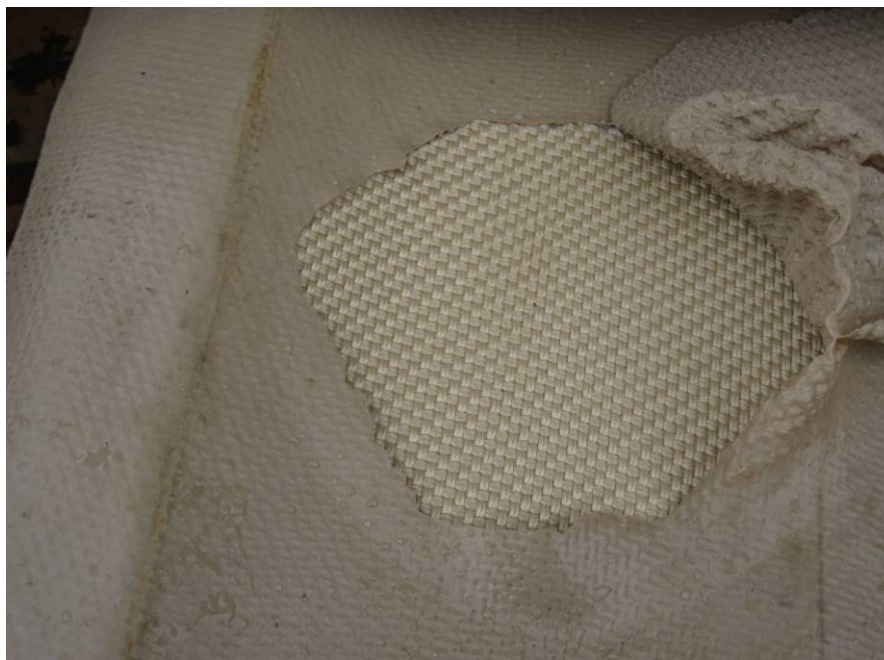
The construction of the Snap-tite conduit was reported to be a through-the-weave extrusion (polyurethane) type of hose with a jacket of twill weave of proprietary yarn. Figure 2.2 shows the exposed jacket (extruded material removed to show the jacket).

**Figure 2.2 – Conduit Jacket and Cover**

Figure 2.2 also shows the texture created in the cover that is a result of the weave pattern. Figure 2.3 shows the similar texture of the liner including what is sometimes referred to as the bias angle of the weave. This pattern may influence the flow performance of the conduit by creating additional pressure drop due to a swirling flow (discussed in Section 7.0).

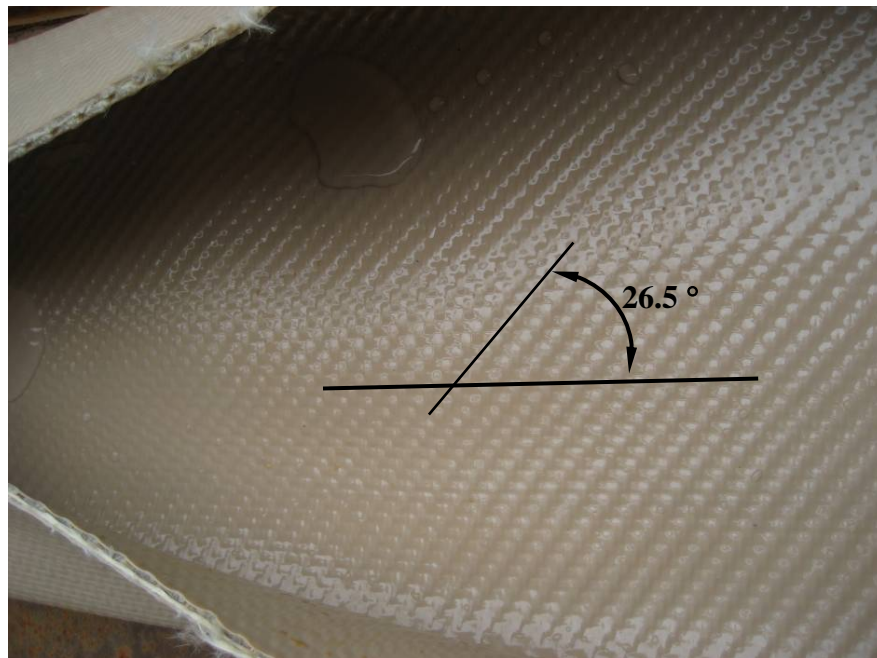
**Figure 2.3 – Surface of Conduit Liner**

Surface roughness and waviness measurements have been obtained from the inner wall of the hose. See Figure 2.3 for a photograph of the inner wall of the hose carcass. The wall exhibits a wavy wall pattern, which is the dominant wall feature. The pattern is the result of the weave pattern that is impressed through the extruded jacket material that forms the inner wall. Also as shown in Figure 2.3, the pattern results in a spiral feature with a bias angle of  $26.5^\circ$  measured from the axial direction of the hose.

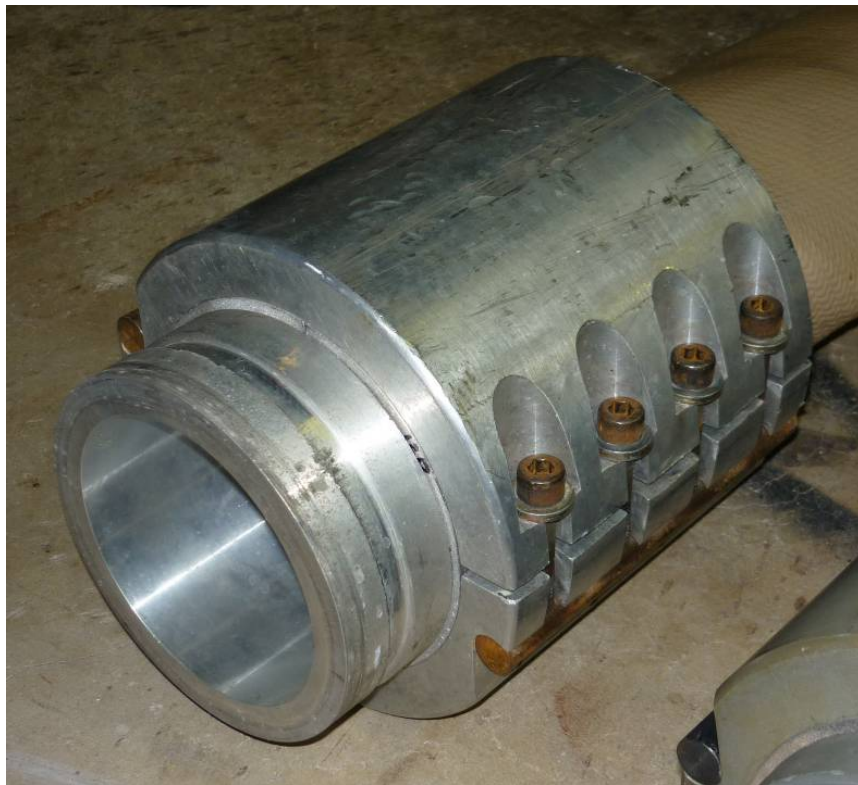
*enhance the quality and performance of the coupling.* (1) The coupling in its present form is relatively long at 11 inches. Therefore, when two couplings are locked together, a hose connection length of 22 inches is formed. This length may pose problems when winding the hose on a spool system. (2) Numerous sharp edges exist and they should be chamfered to protect from cutting o-rings and to reduce crack initiation sites that may lead to fatigue problems. (3) The “inside of the hose” end of the tailpiece should be chamfered to reduce flow losses caused by sharp edges. Figure 2.4 through Figure 2.8 show photographs of the end fittings and their assembly.

**Figure 2.4 – Assembled End Fitting**

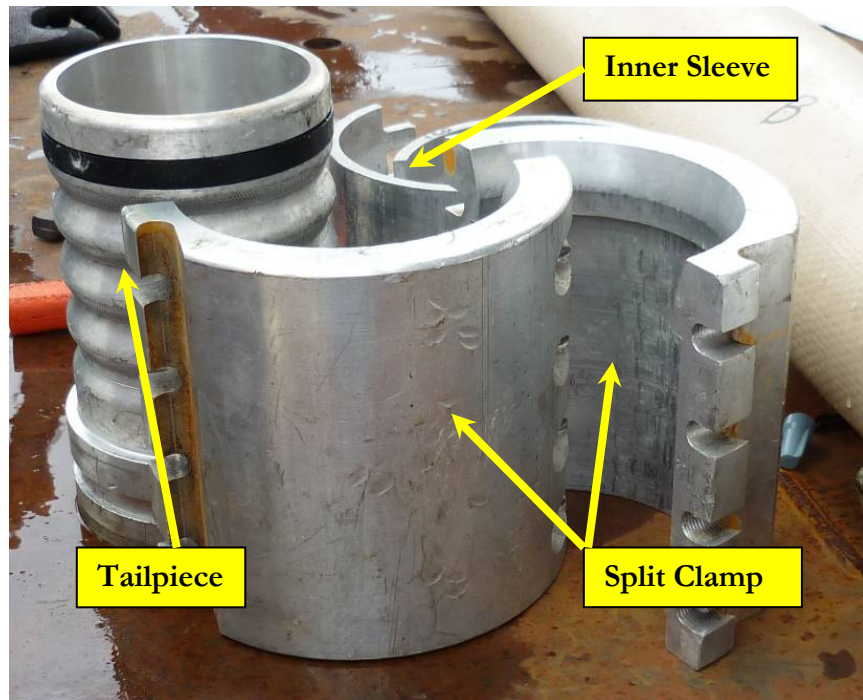
**Figure 2.5 – Disassembled Components of End Fitting**

The assembly procedure involves first sliding the hose over the tailpiece until it butts against a collar on the tailpiece. After the tailpiece is fully seated into the hose, the inner sleeve is lightly hammered into position around the portion of the tailpiece covered by the hose. Finally, the split clamp is installed around the inner sleeve and held together with two screw assemblies. The

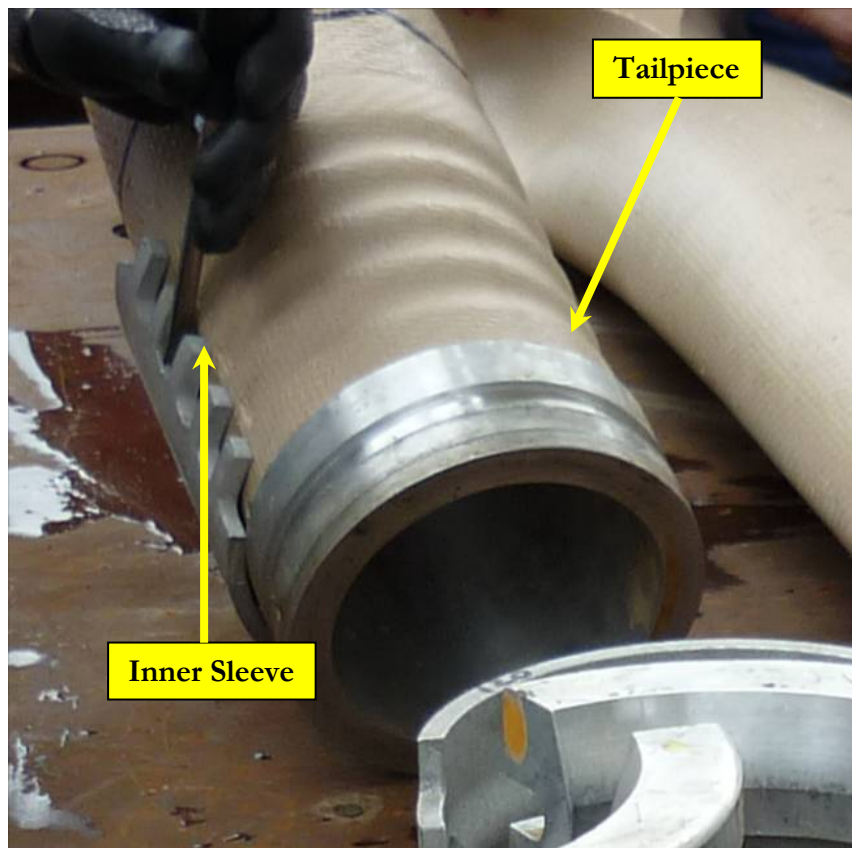
**Figure 2.6 – Tailpiece Inserted in Hose and Inner Sleeve Being Installed**

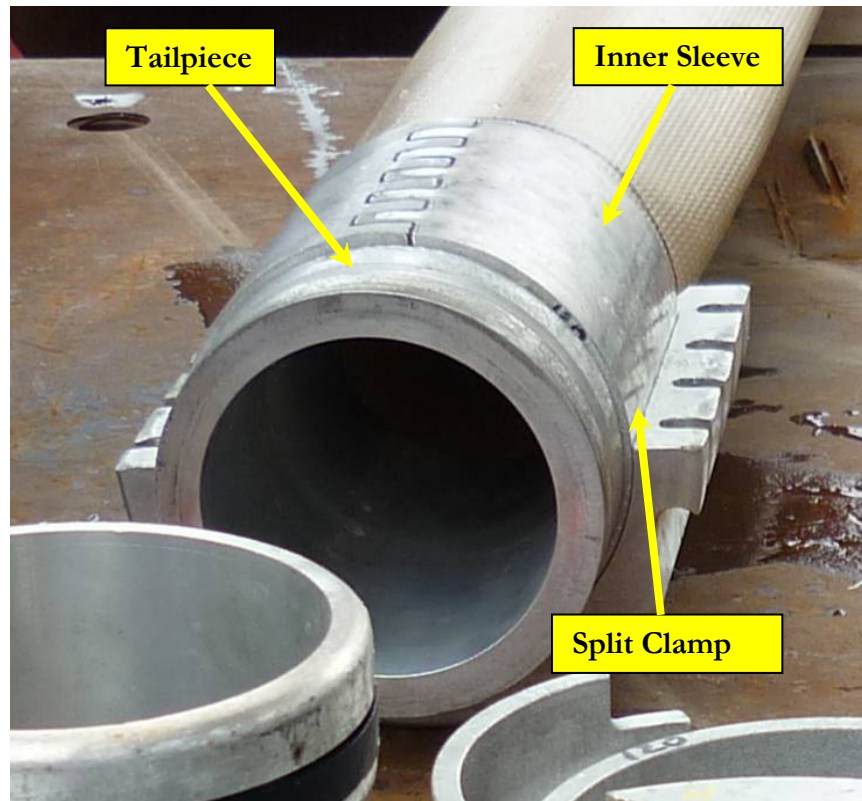
**Figure 2.7 – Inner Sleeve Fully Installed and Split Clamp Being Installed**

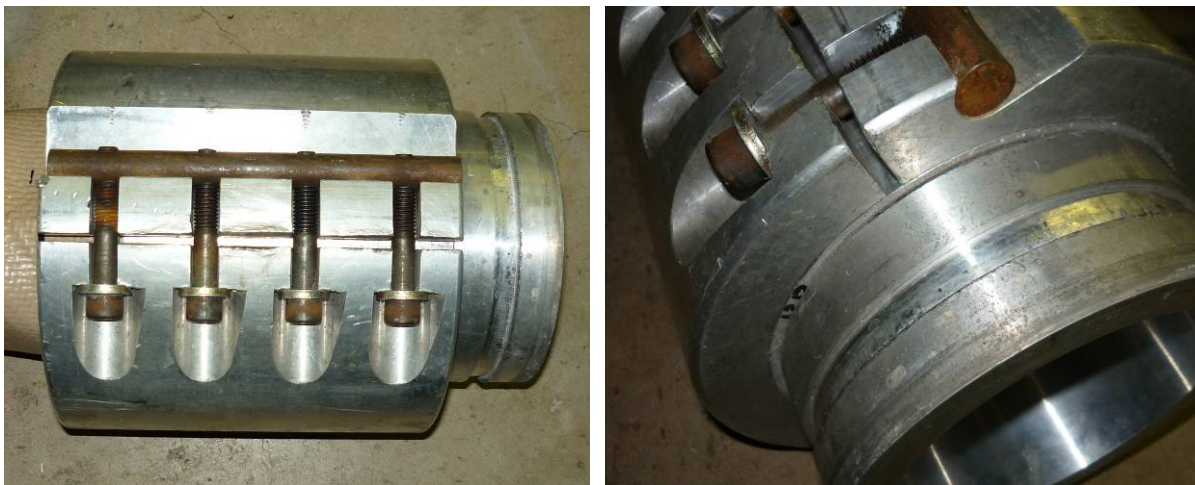
**Figure 2.8 – Screws Fastening Split Clamp Together – Used on Both Sides of End Fitting**

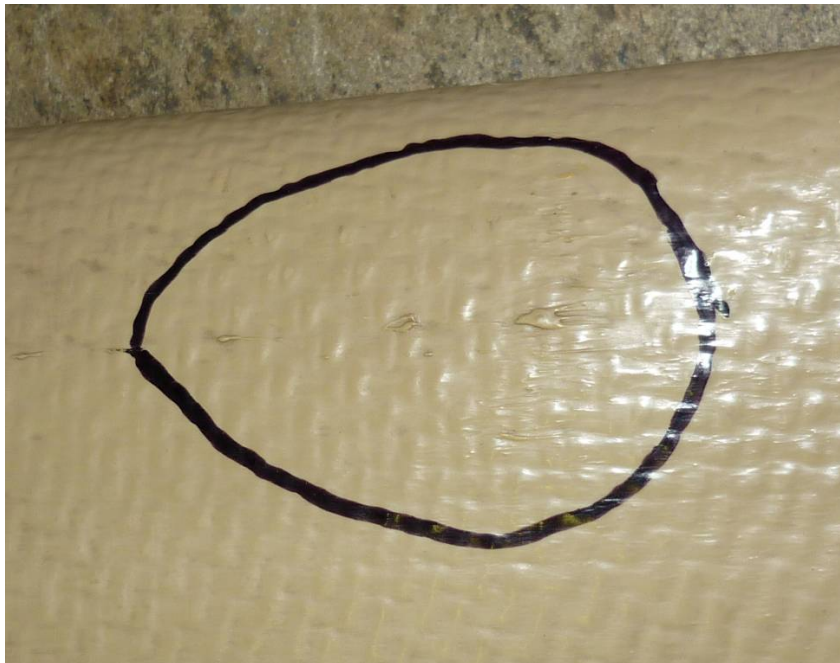
During inspection of the hose samples, there were no major defects or damage noted for any of the hose samples. There were a couple of minor flaws noted on the outer surface of some of the samples. Primarily there were two types of flaws found. One flaw consisted of small dimples of extra material present on the outside of the hose, as shown in Figure 2.11. The other flaw consisted of smooth areas on the outer texturing of the hose, as shown in Figure 2.12. None of these flaws appeared to be significant and did not appear like they would affect the performance of the hoses. No actions were taken to repair the flaws or to replace the hoses.

**Figure 2.11 – Example of Surface Defect Noted During Inspection**

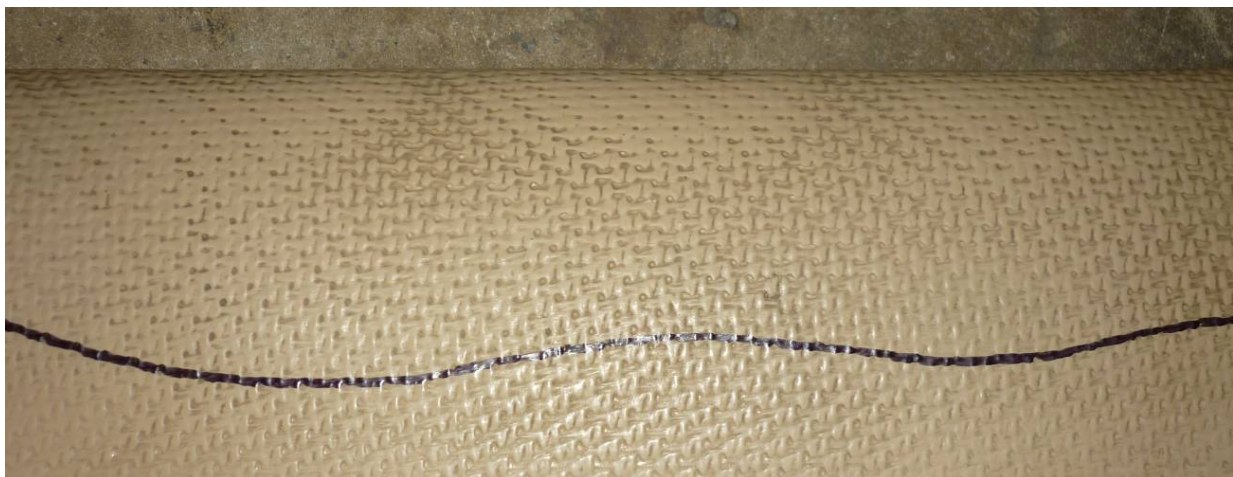
**Figure 2.12 – Another Example of Surface Defect Noted During Inspection**

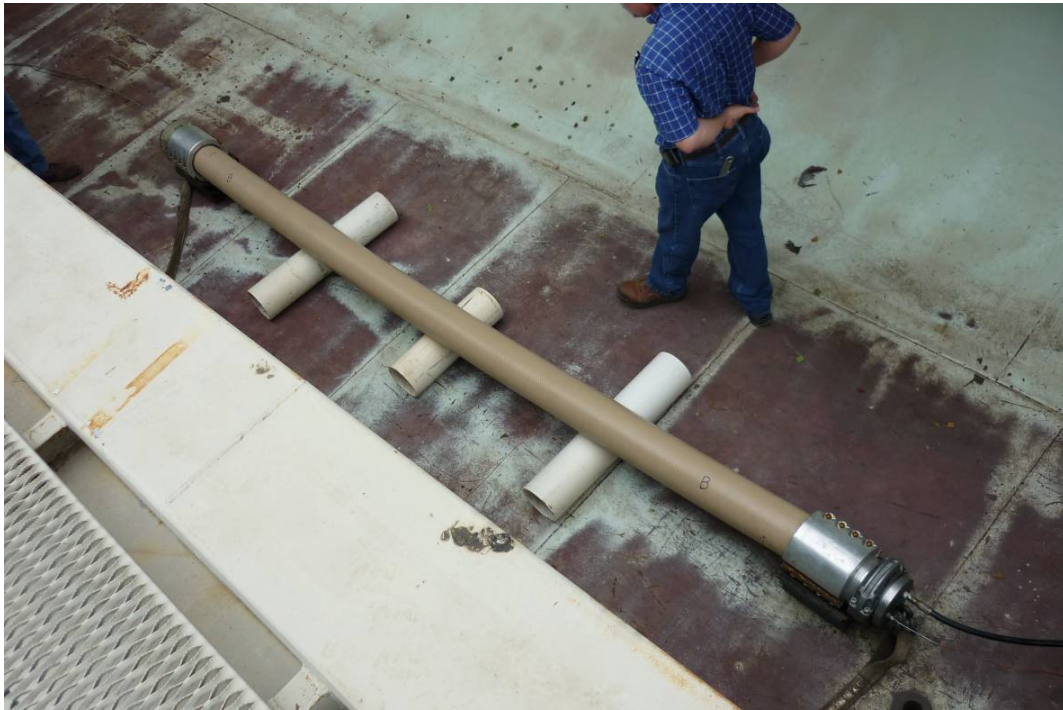
**Figure 3.1 – Hose Sample B - Burst Test Setup**

Figure 3.1 through Figure 3.9, show the setup of each hose sample as well as the respective failure. The pressure time-history graphs of the burst test data can be found in Appendix A and Engineering Data Sheets are found in Appendix B.

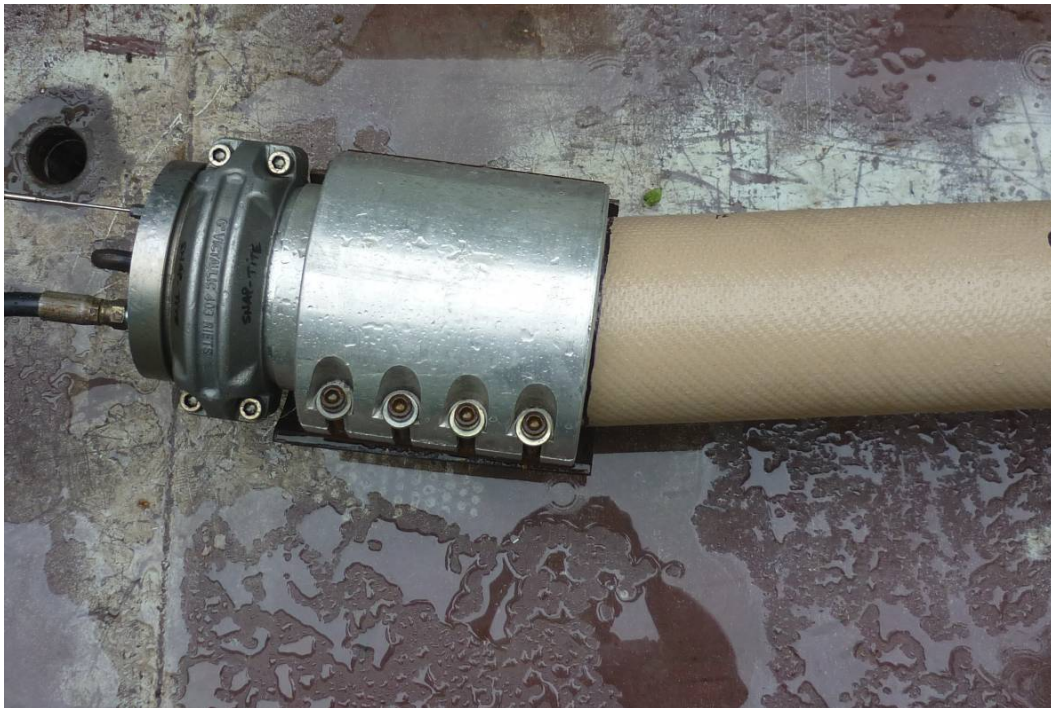
An interesting behavior was noted while setting up the initial burst test. While performing some checks it was noted that the end fittings “cocked” on the ends of the hose when the hose was pressurized. Closer inspection determined that slippage was not occurring between the hose and end fitting – circumferential lines that had been drawn on the OD of the hose at the inboard edges of the split clamps when the end fittings were installed remained at the inboard edges of the clamps (see Figure 3.2). During the course of the testing, it was noted that the end fittings would consistently become “cocked” to some degree on every hose. The “cocking” of the end fittings becomes evident at low pressures. Snap-tite personnel stated that they noted the same “cocking” behavior at their facility and is caused by the construction of the hose during the extrusion process and is not caused by the construction of the end fittings or an incorrectly assembled end fitting. The Snap-tite representatives stated that the “cocking” of the end fittings would not affect the test results. None of the test samples burst at the end fittings.

**Figure 3.2 – Hose Sample B – ‘Cocked’ End Fitting at 60 PSIG**

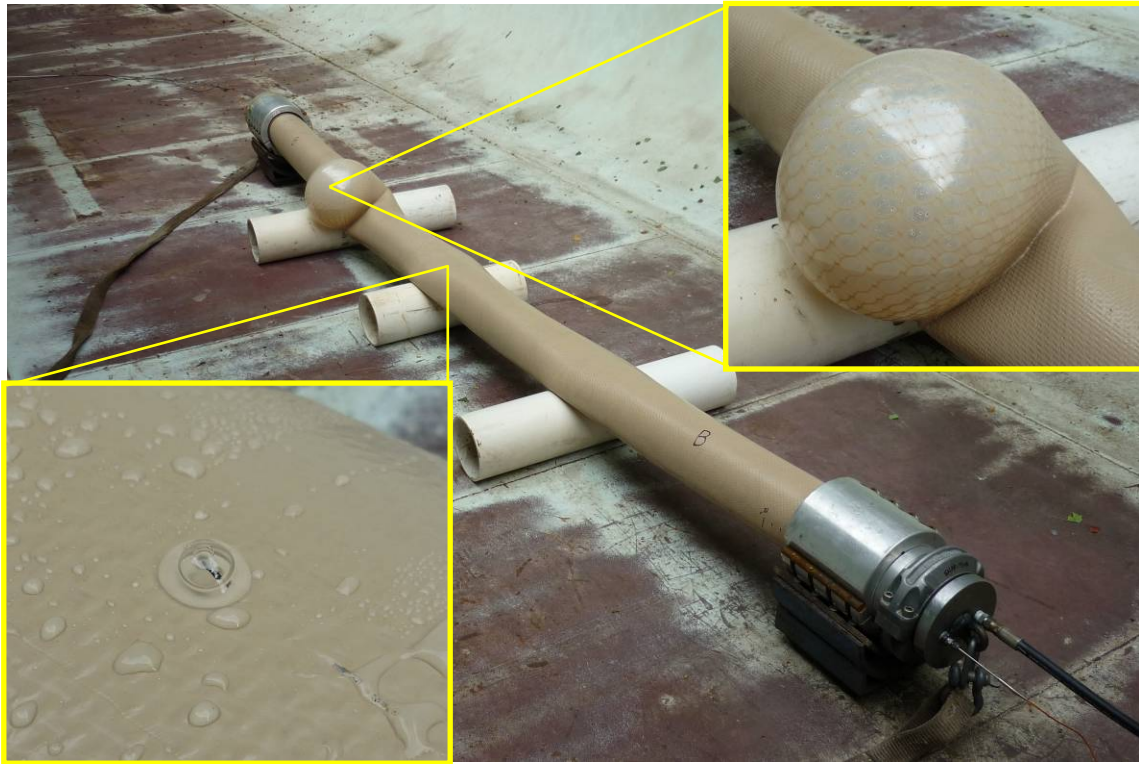
Sample	Length (ft.) <sup>1</sup>	Burst Pressure (psig)	Failure Mode	Cycled Tested Before Burst Test
B	13.08	1966	Pin holes in liner, no apparent yarn break	No
C	17.80	1467	Large axial tear, 65+ weft yarns broken	Yes
D	14.92	1896	Small hole, 1-2 weft yarns broken/protruding	No
E	14.31	1621	Small hole, 2 weft yarns broken	Yes

**Figure 3.3 – Hose Sample B Failure**

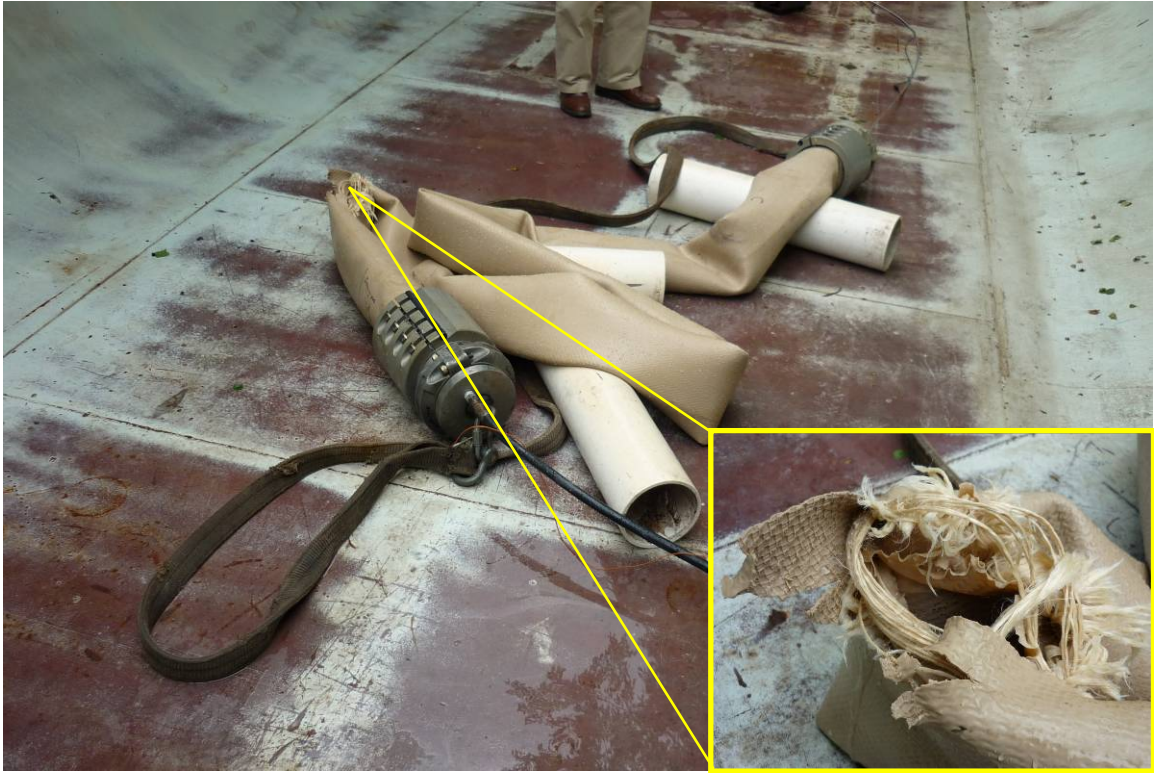
**Figure 3.5 – Hose Sample C Failure**

<b>Test notes/observations</b> <u>approx. 65-75 circumferential threads failed</u> <u>hose ruptured in 1 axially oriented tear, approx 7" long. located along the fold (approx.)</u>

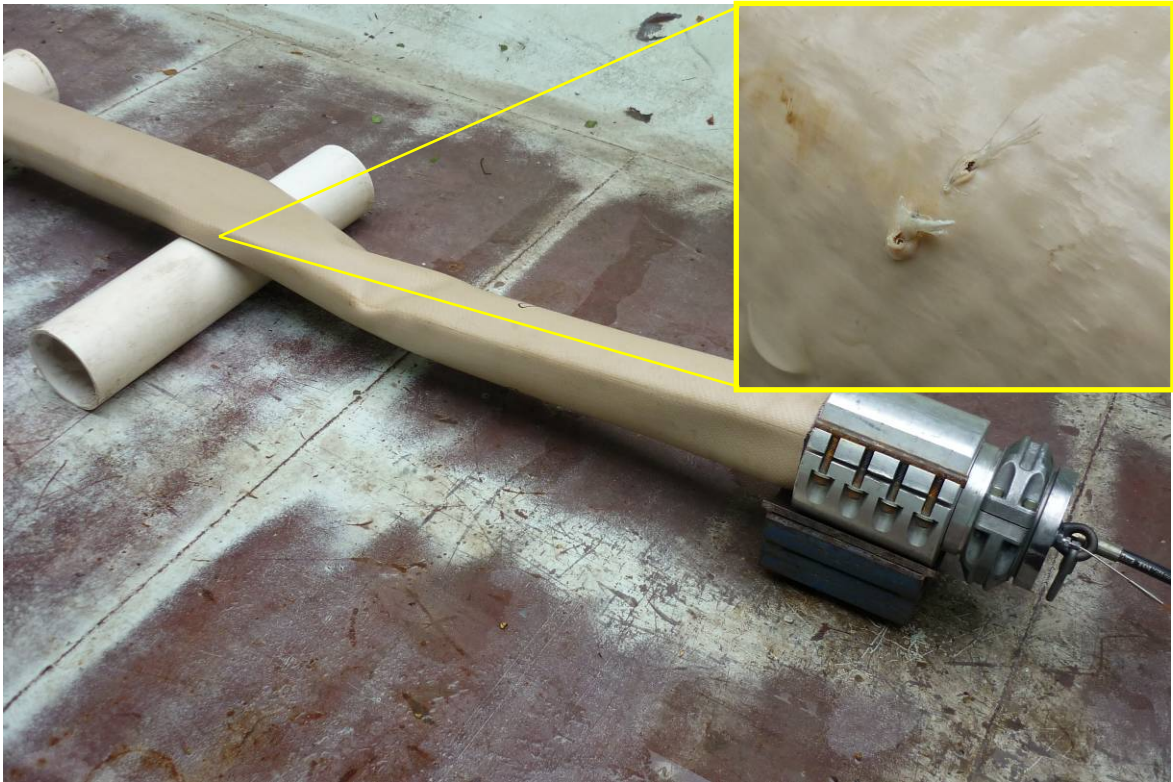
**Figure 3.7 – Hose Sample D Failure**

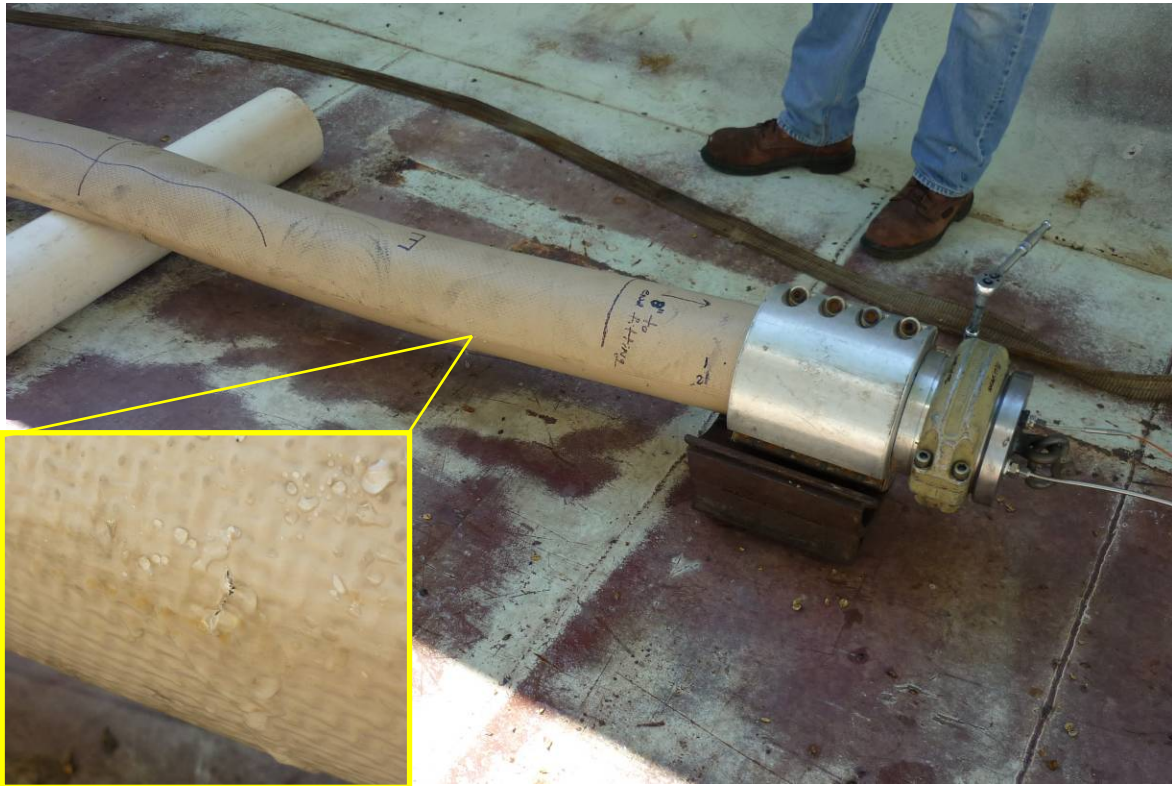
**Figure 3.9 – Hose Sample E Failure**

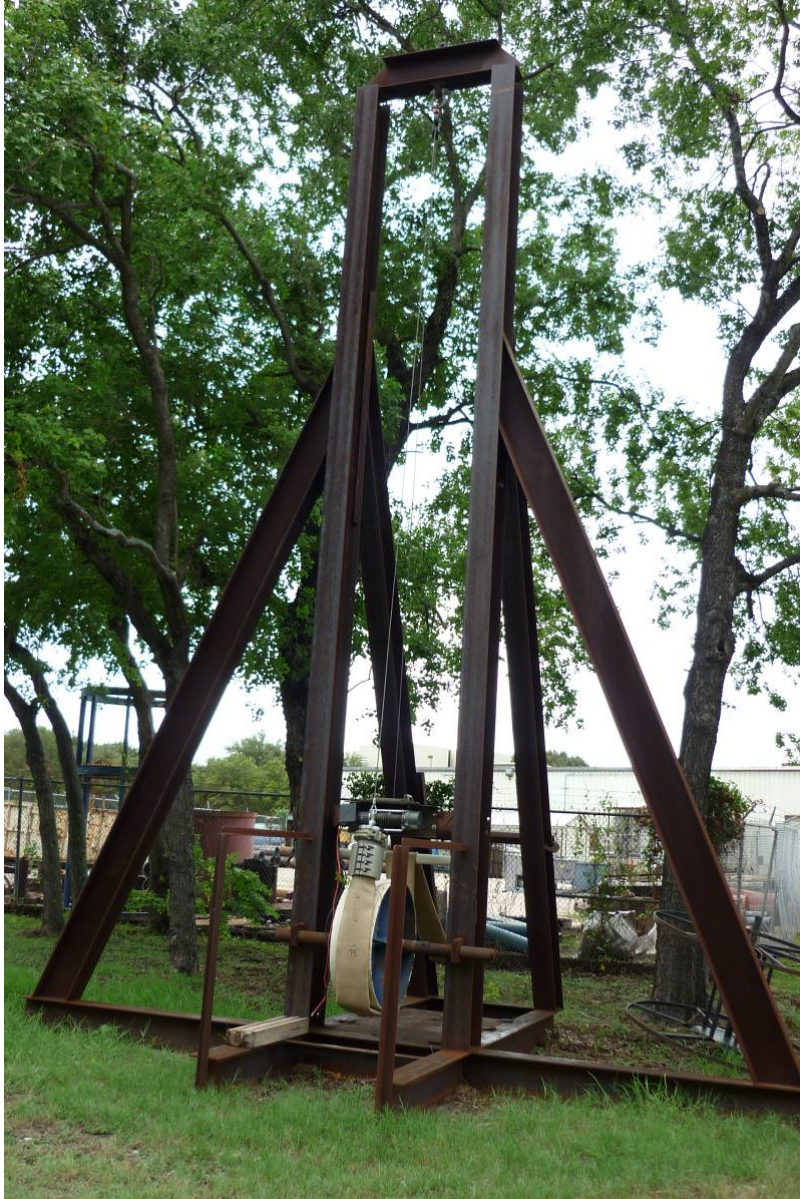
Cyclic tests were used to simulate conditions that the actual conduit could experience during emplacement and retrieval in the field when the hose is wrapped and unwrapped on a spool during these events. Conduit sections were subjected to alternating bending around a 3-inch radius and a 36-inch radius, and pressurization cycles. For the pressurization cycles, a working pressure of 650 psig was used. Of the five hoses delivered by Snap-tite, two of the 15-foot hoses were cyclic tested.

**Figure 4.1 – Cyclic Testing – Bending Test Fixture (View 1)**

Figure 4.1 through Figure 4.7 shows the setup use for cycle testing. The pressure time-history graphs of the pressure cycle data and the burst test data can be found in Appendix A.

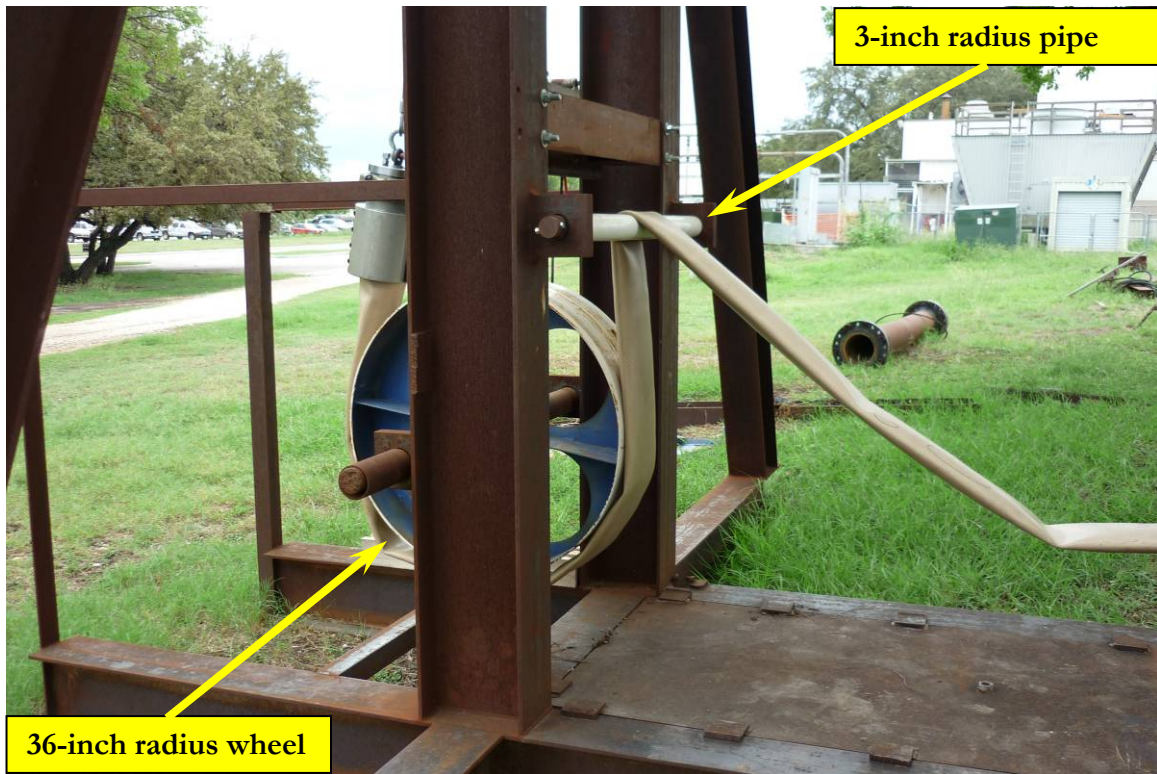
Figure 4.2 – Cyclic Testing – Bending Test Fixture (View 2)

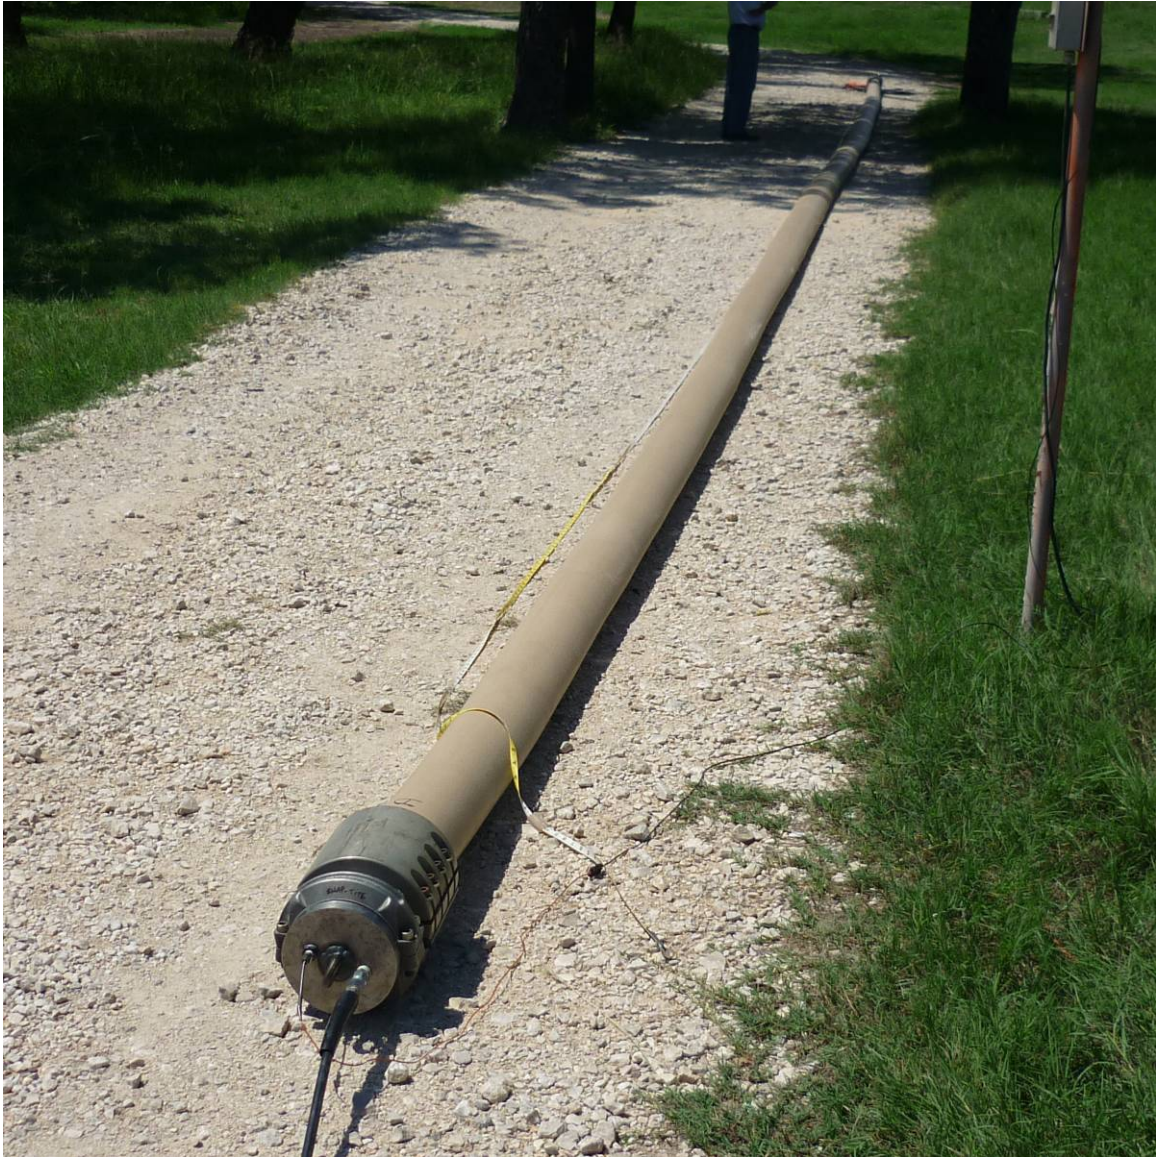
**Figure 5.1 – Hose Sample A – Elongation and Twist Test Setup**

Figure 5.1, shows the setup of the hose sample for the twist and elongation test and Figure 5.2, shows the pinhole leak that was discovered on the conduit sample. The pressure time-history graphs of the twist and elongation test data can be found in Appendix A.

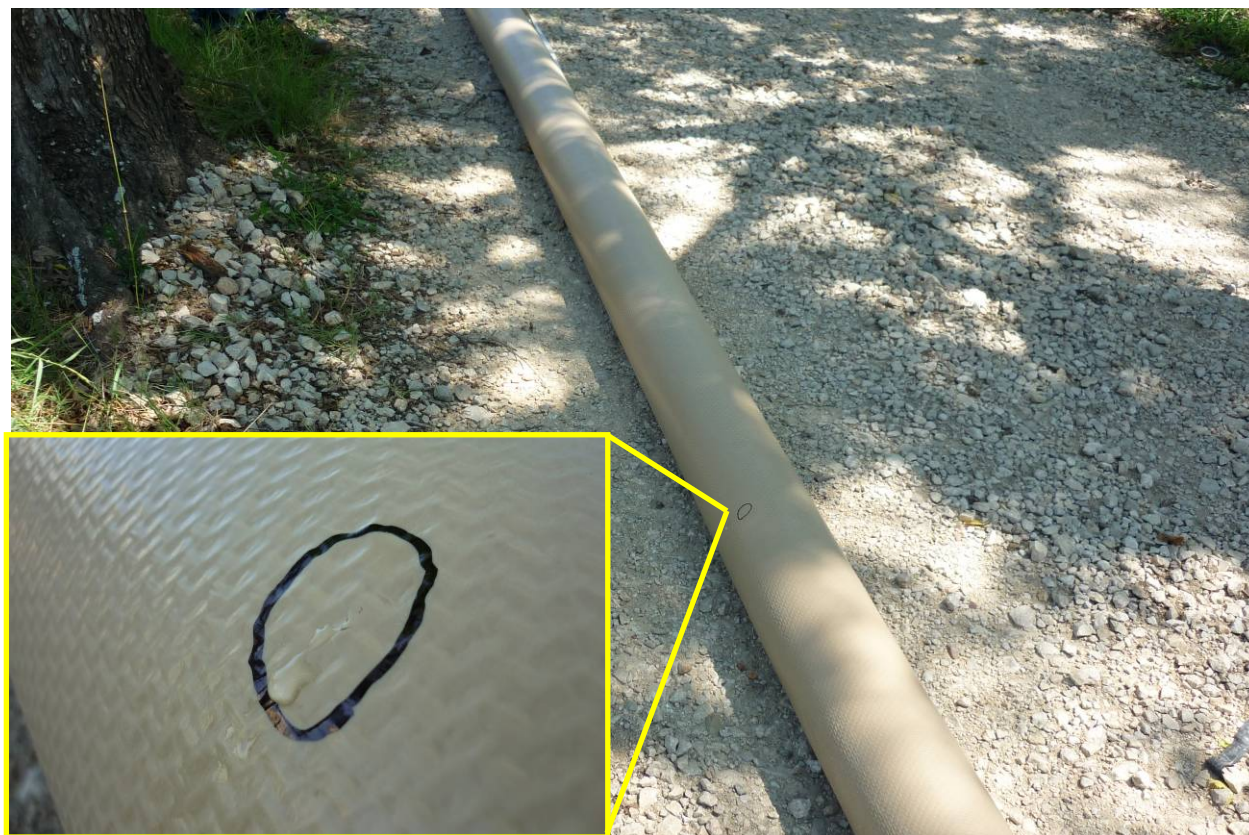
While setting up the twist and elongation test, it was noted that the conduit had a small pinhole leak. This leak was not caused by the test or from the internal water pressure. It is theorized that the leak was caused in the shipping process. The 100-foot conduit was located at the bottom of the shipping crate and the conduit may have been sitting on a staple holding the cardboard crate together or from a wood splinter on the wood pallet. The leak was noted at low pressure (~60 psig). The pinhole did not appear to grow and the flow rate of the leaking water did not appear to grow either as the water pressure was increased from 60 psig to the working pressure (650 psig).

**Figure 5.2 – Hose Sample A – Pinhole Leak**

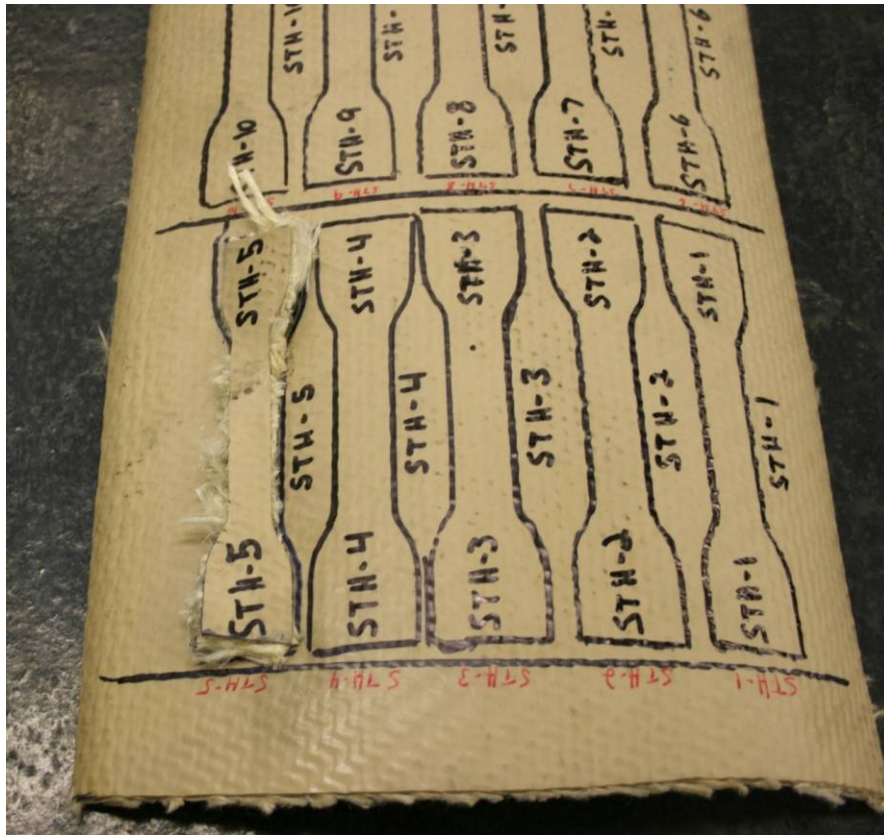
A short length of the 100 ft hose was used for material for extraction of 15 tensile coupons (Figure 6.1). An ASTM D412-A die was used to stamp out the specimen profile and followed up using a hobby knife and cutting shears to completely remove the specimens from the parent hose material. A representative sample is provided in Figure 6.2. The D412-A die provides samples of approximately 0.5 inches in width and this allows the sample to include a representative number of longitudinal (warp) fibers.

**Figure 6.1 - Specimen Layout and Extraction from Parent Hose Section**

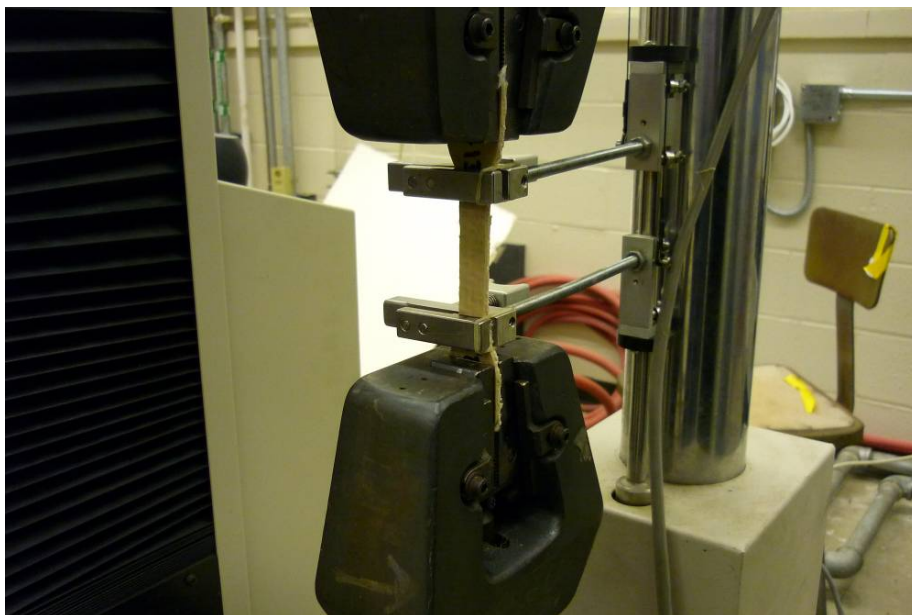
Testing was performed per ASTM D412 at a displacement rate of 20 in/min. A 20-kip servomechanical test frame (Figure 6.3) was used with a 2.5-kip load integrated into the load train given the anticipated loads. Mechanical clamping grips were used to secure each coupon end during testing. A high elongation extensometer was utilized to measure gage length extension during each test. The initial gage length for each test was 2-in and the post-test strain calculations were based on a nominal gage length of 2-in. Testing was performed in laboratory ambient conditions; nominally 72°F and 30-40% RH. It is important to note that the conditioned coupons remained in a bath of their respective conditioning fluid until just prior to testing.

**Figure 6.3 – Test Sample Mounted in Tensile Test Frame**

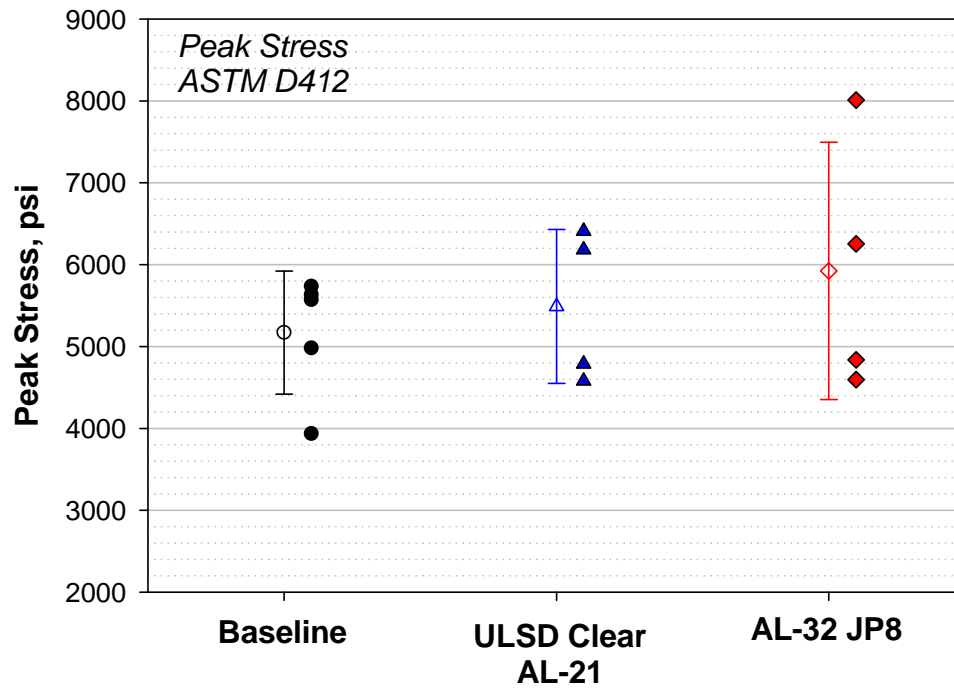
Figure 6.4 - Comparison of the Three Conditions based on the Peak Stress

Tabular summaries of the tensile results are shown in Table 6.1. The peak stress and strain at peak stress is included in the table as a means of comparison. In addition, comparative plots are included that graphically compares the results in terms of the peak stress and the strain at peak stress (Figures 6.4 and 6.5, respectively). When comparing mean values, it appears the tensile properties presented show a slight increase with regards to the peak stress achieved while the strain at peak stress decreases for the conditioned coupons as compared to the baseline condition. It important to note that there is significant levels of scatter demonstrated for all conditions tested and a larger sample size would further help understand the change in properties.

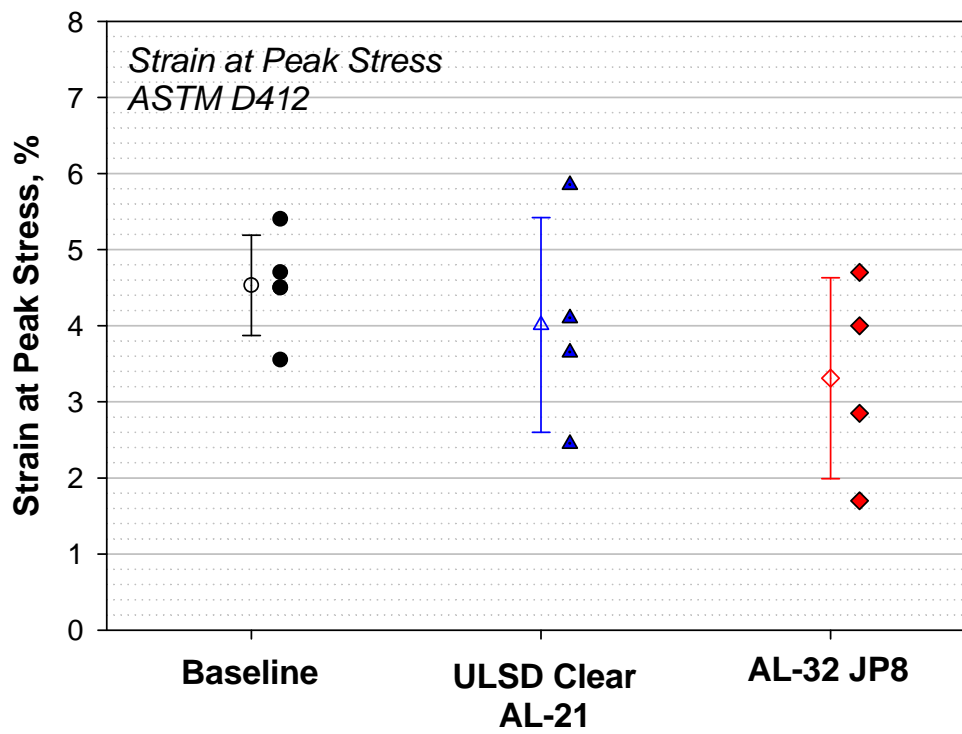
Figure 6.5 - Comparison of the Three Conditions based on the Strain at Peak Stress.

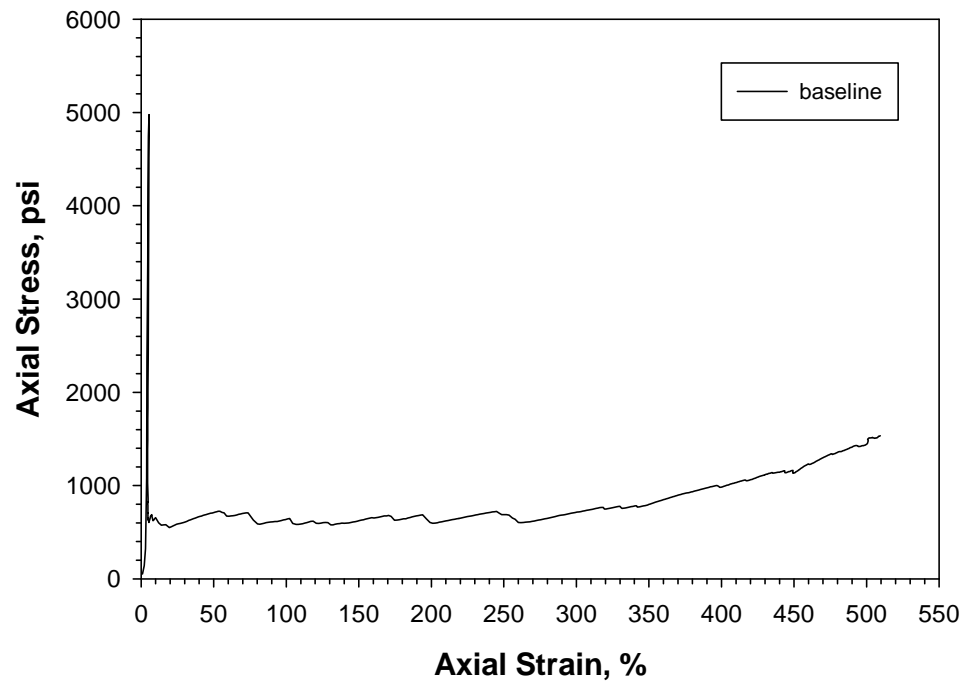
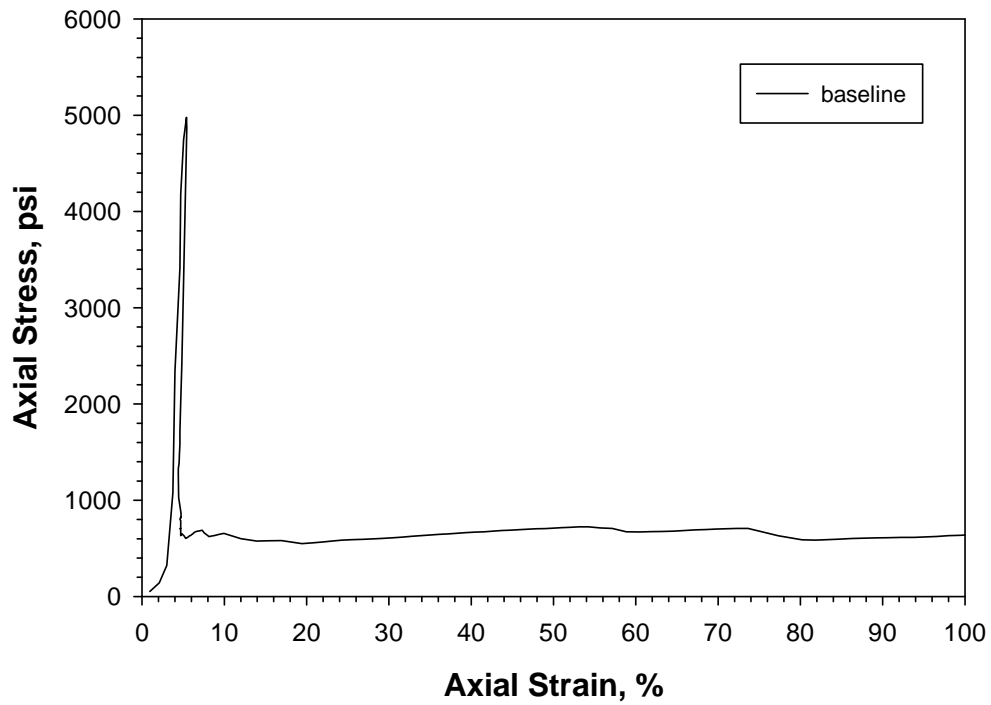
Figure 6.6 - Representative stress-plot behavior for the baseline condition (coupon STH-11).

In addition to the summary table and plots, representative stress-strain plots are provided for each of the conditions evaluated in Figure 6.6 though 6.8. It is presumed that the rapid increase in stress (stiff behavior) at the beginning of the test is a result of the fibers carrying most of the applied tensile load. However, once those load carrying fibers fail, load is then transferred to the outer, more compliant, coating material and thus the high level of elongation at a lower stress level.

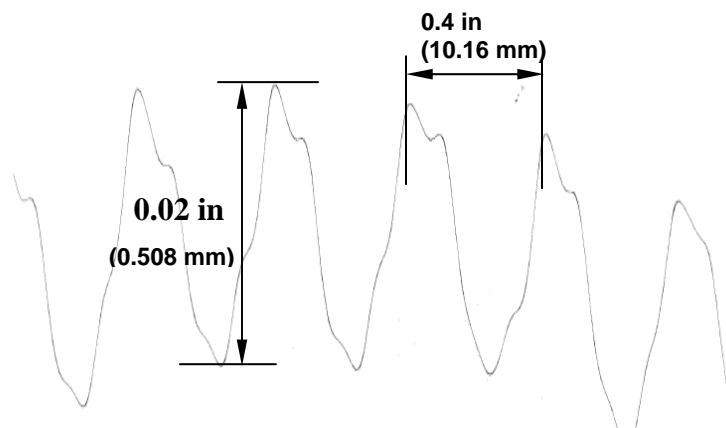
A surface-profiling instrument was used to measure the wavy pattern peak-to-peak height, period, and the surface roughness that is superimposed on the wavy pattern. As shown in Figures 7.1 and 7.2, the surface roughness exhibits a Ra value of 45.4  $\mu\text{inch}$  superimposed on the wavy pattern that exhibits a peak-to-peak height of approximately 0.02 inches. The wave period is about 0.4 inches. If we assumed a sinusoidal shape for the wavy wall (close but not exact), the root-mean-square value (rms) would be 0.707 times the peak height or .00707 inches ( $0.707 \times 0.02/2$ ). For rough order calculations, this would give a hydraulic roughness ( $e/d$ ) for a nominal 6-inch diameter hose of approximately  $0.00707/6 = 0.0012$ , where the surface roughness is denoted by  $e$  and the interior diameter is  $d$ . From previous experience, the author has tested a similar hose and has found that the wavy wall roughness controls the pressure drop and not the surface roughness superimposed on the wavy wall.

**Figure 7.1 - Profile of Wavy Wall (Vertical Scale Amplified)**
